Standard Electric Public Clock System RESTORATION

by James Gardner (CT)

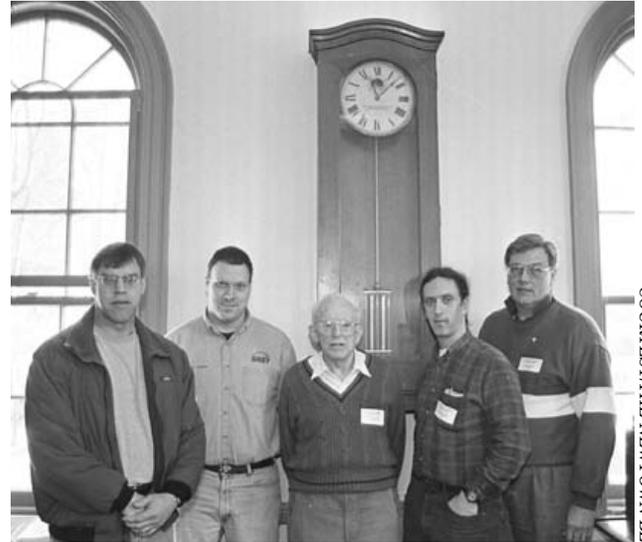
Figure 1. Five members of the committee that restored the clock system in front of the master clock in the town clerk's office. Left to right: Jim Gardner, Chris Locke, Dana Blackwell, Jim Katzin, and Jerry Valenta. Not pictured: Clark Kathan, Jim Storrow, and Pete Zasada.

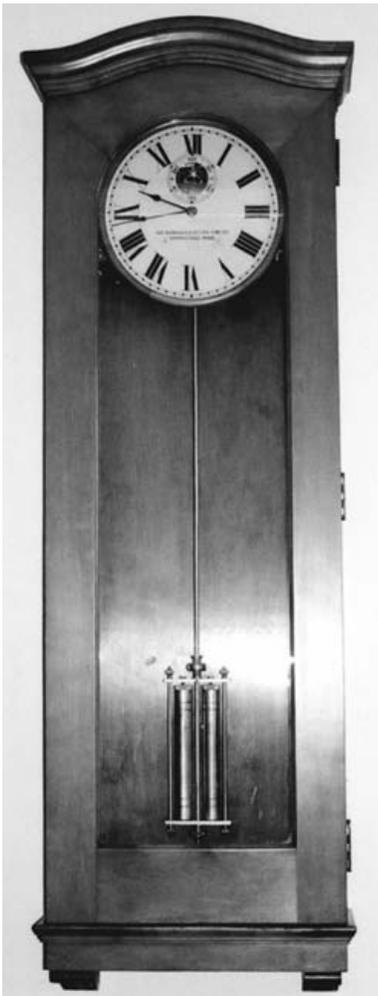
Figure 4. The master clock.

The 60-beat, self-winding master clock is housed in the town clerk's office, the top of the case having a graceful eyebrow design, silvered dial, and wood bezel. The clock has a mercurial compensating pendulum. The pendulum is composed of two steel, nickel-plated jars, filled with refined mercury. Surrounding the clock dial were four relay switches to send impulses to the secondary clocks once a minute. One relay had been replaced and the original one stored in the bottom of the clock case. At the bottom of the case were the winding contact, the advance contact, and single point switches for all secondary clocks. The movement was complete and in good shape. Cleaning of the movement was done as well as refortification of the worn iridium platinum contacts. Later, we were fortunate to have an original set of unused iridium platinum contacts donated to the project. With the new contacts, the master clock would keep excellent time. The original wiring at the top of the case, that carries the electrical

On the master clock, two nuts are found on the mercurial pendulum for regulation. Turning the lower nut to the right raises the center of gravity of the pendulum, and turning to the left does the opposite. The nut has 50 divisions, and turning it two notches will affect the clock regulation one second in 12 hours. A micrometer adjustment to the regulation of the clock can be made with the upper nut. One complete turn here will affect regulation by a fraction of a second in 24 hours.

We applied the following formula for the lower (macro regulation) nut that allows us to keep the master clock well regulated:

1. Count the total hours since the last adjustment.
2. Convert to minutes lost/gained to seconds.
3. Divide #1 by 12.
4. Divide #2 by #3.
5. Multiply #4 by 2 = total number of macro adjustments (notches) for rate adjustment.

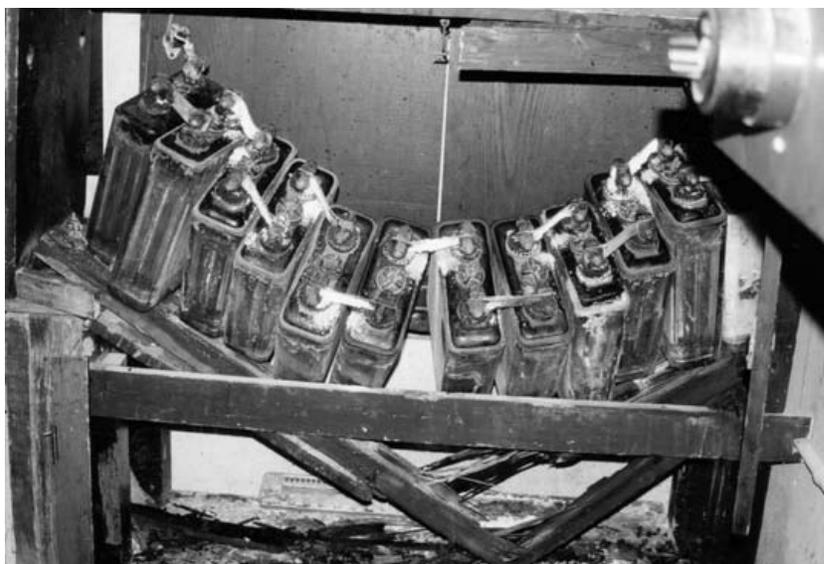
The clock system is powered by 120-volt AC with a 24-volt DC charger and batteries as backup power in the event of the loss of AC power. The system's power center was found in a dilapidated state one floor below the town clerk's office. The wooden cabinet holding the 12 two-volt Manchex Exide batteries was partially collapsed, with the batteries hanging out of the cabinet. The collapse was due to age, lack of maintenance, and spilled electrolyte. The batteries

Figure 5, above. Pre-restoration batteries in dilapidated case.
Figure 6, below. The restored battery cabinet.

needed to be replaced, so we replaced them with Exide lead calcium general purpose CC-3 type batteries. They are low maintenance, have a 20-year warranty, and can power the clock system for many hours if AC power is ever interrupted.

We determined that the 1985 replacement battery charger was inadequate to sustain power to the system. Through a donation of an appropriate battery charger, the system needs were met. Jerry Valenta, whose skills run from clock repair to woodworking, cleaned all the wood parts, replaced rotted parts, and repainted and reinstalled the cabinet.

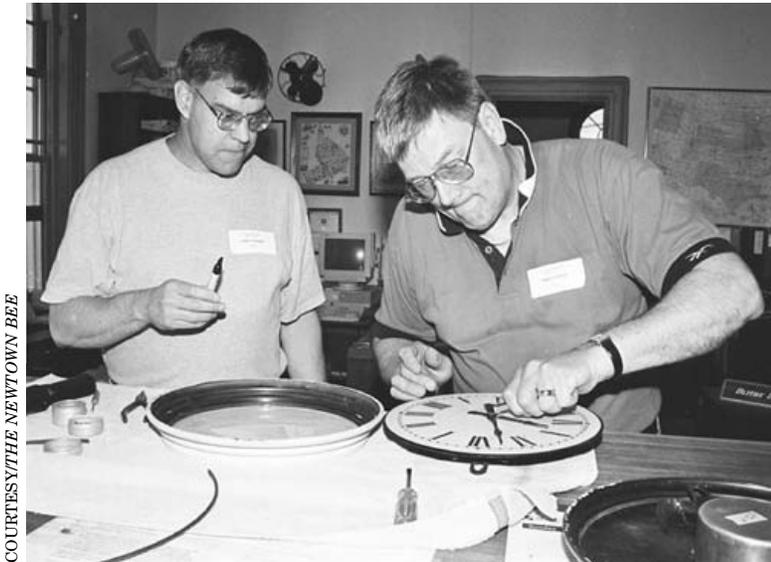
Figure 7. Jim Gardner and Jerry Valenta at work on a secondary clock.

The secondary clocks are extremely simple in design, and function for years without the need for any type of lubricant. These secondary clocks are advanced every minute by a one-second impulse from the master clock. The impulse activates a magnet, causing a pawl

to lift over the current tooth and position itself on the next tooth, and when the magnet releases, advances the hand one minute. The amount of pawl clearance is controlled by an adjustment screw for the magnet. A thin wire spring resting over the top of the pawl ensures that the pawl returns to its proper position.

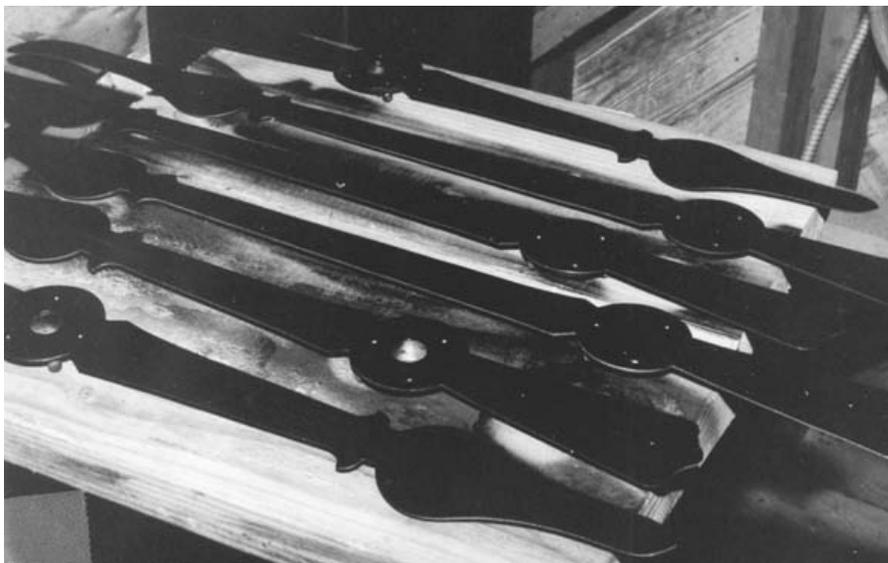
Figure 8. Repainted tower clock hands.

The clock tower has secondary movements and dials facing north, east, and south and all had their original parts. The west opening has only the dial. Once we reviewed the original wiring diagrams, we determined there was never any intent to have anything other than a dial in the west tower opening. Dials were removed, cleaned, and the numerals were repainted. Likewise, all hands were repainted a flat black.

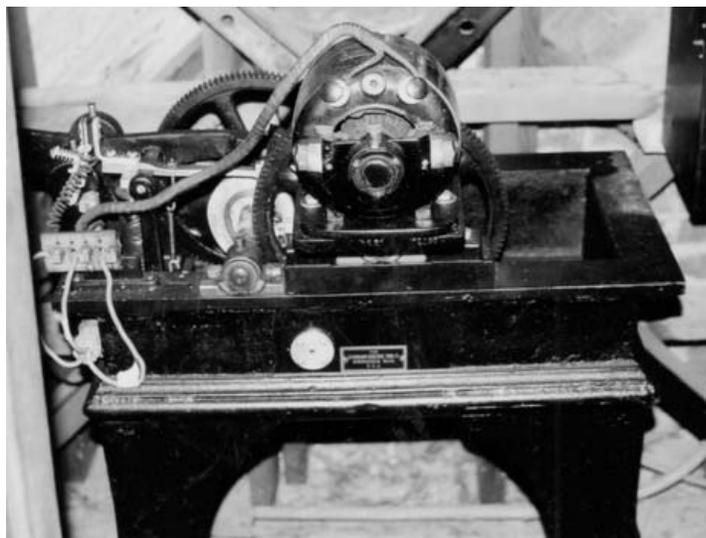
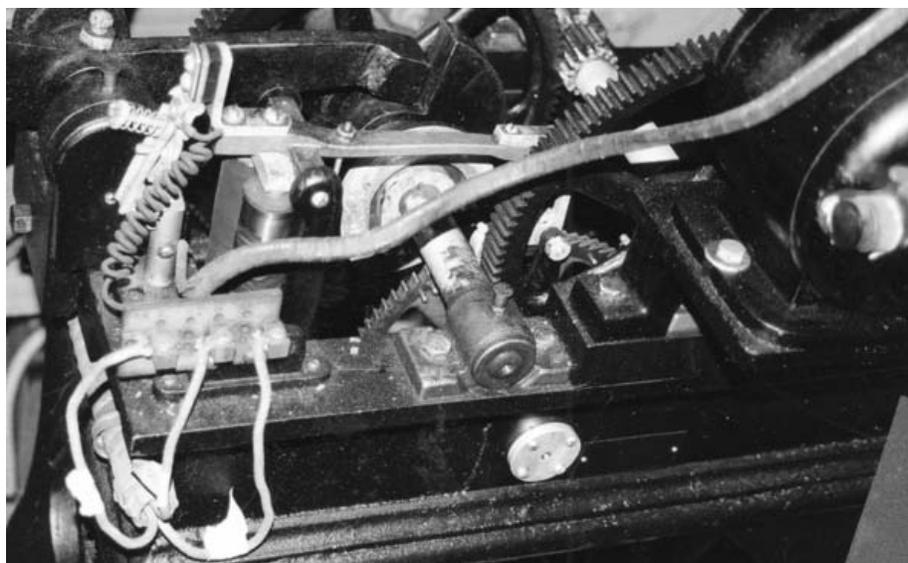
Figures 9 and 10, right and below. The strike apparatus.

The strike apparatus is located one level below the secondary clocks and dials in the clock tower. The motor was removed, cleaned, and new brushes installed, and all parts except the frame were removed off the premises for a thorough cleaning. The wrong oil had been used over time as well as too much of it, necessitating the frame being stripped and cleaned. We noted that the electrical contacts on the apparatus had their silver plating completely filed off through an earlier inappropriate attempt at repairs. We had the contacts re-silvered as well as new insulation bushings installed. Wiring from the wall timer (bell strike) was found mis-wired and was corrected.

The bell is located two levels above the strike apparatus, with the control arm on the strike apparatus attached to the pipe rod extension operating the bell hammer on the hour. The bell is a 1929, cast by the Meneely Bell Co. of Troy, New York. The original wood base for the strike hammer was weak and deteriorated, and was replaced to ensure the correct operation of the strike hammer.
